Assessment of Dam Safety

Coal Combustion Surface Impoundments (Task 3)

PacifiCorp

Naughton Power Station

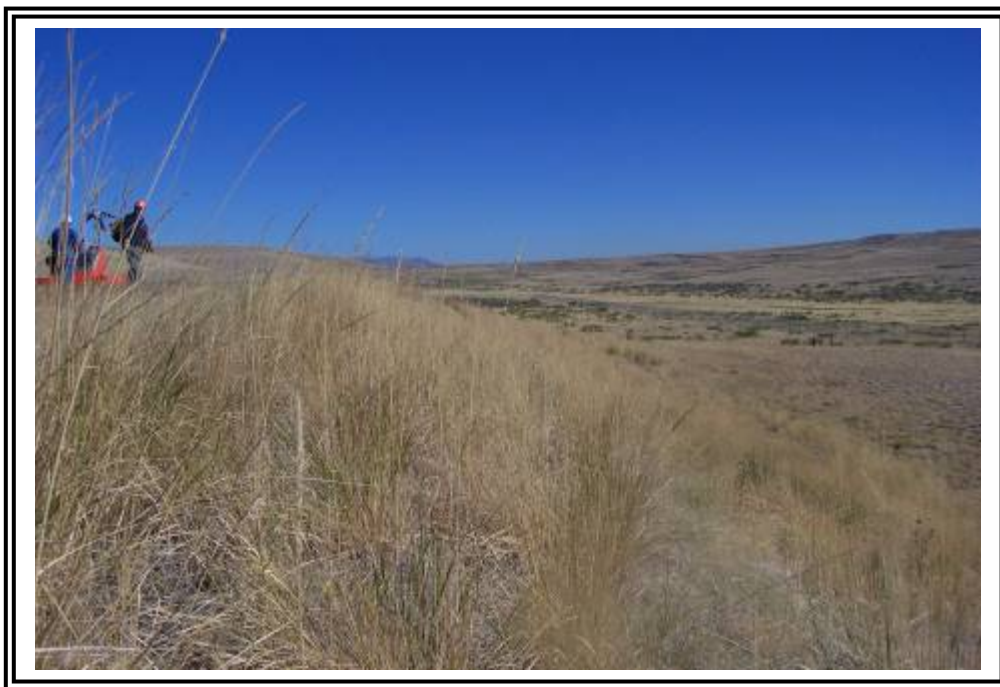
39

Downstream slope looking northeast at south corner.

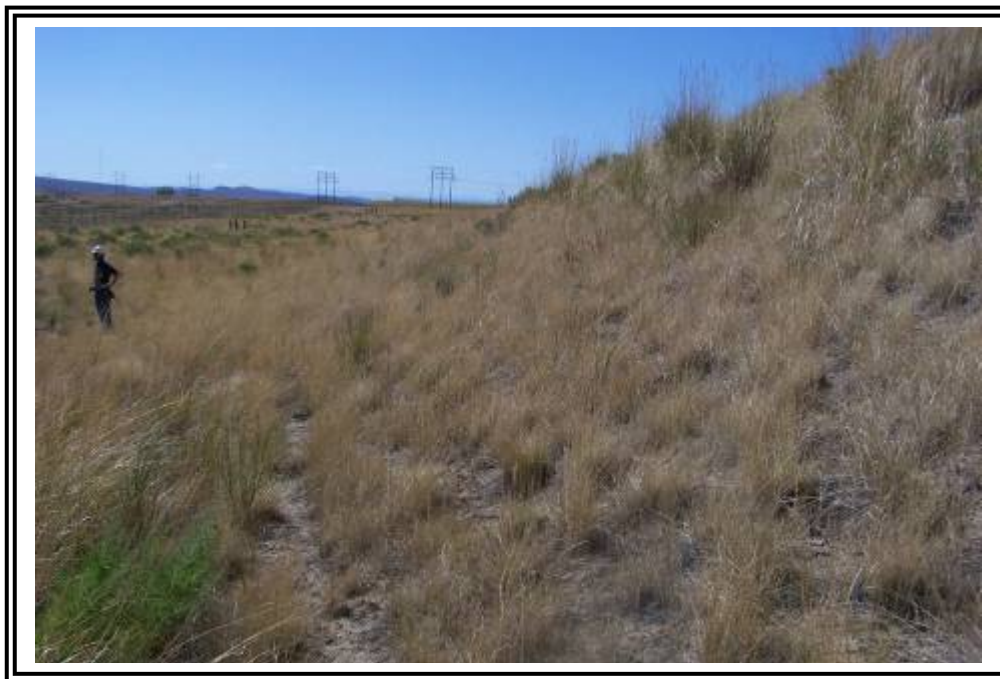
40

Downstream toe and slope at south end of east dike looking south.

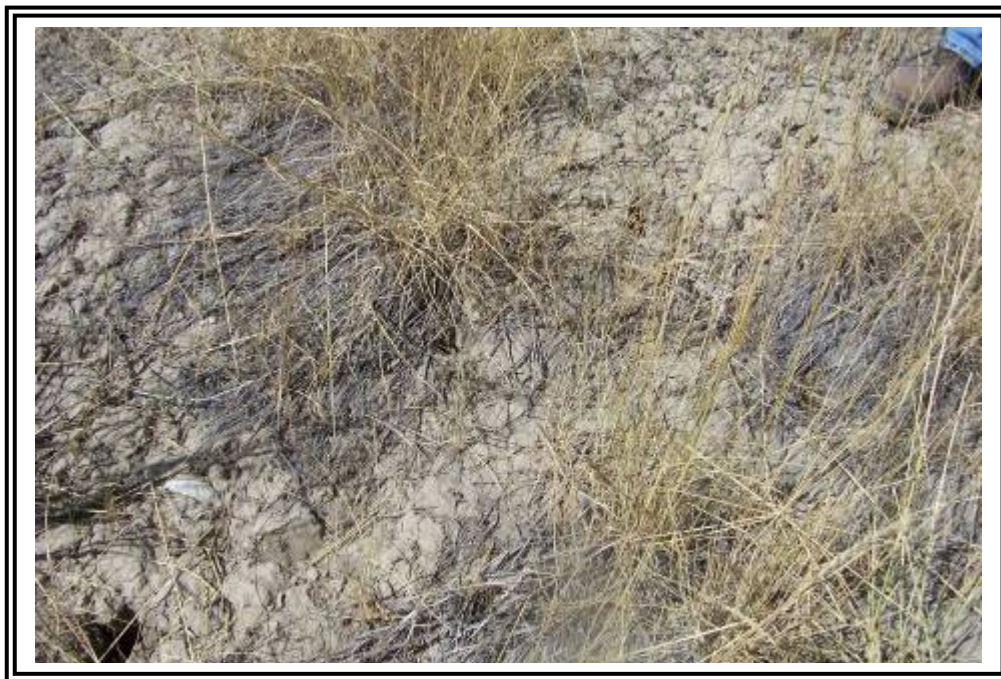
42

Animal burrow and sparse vegetation on east dike.

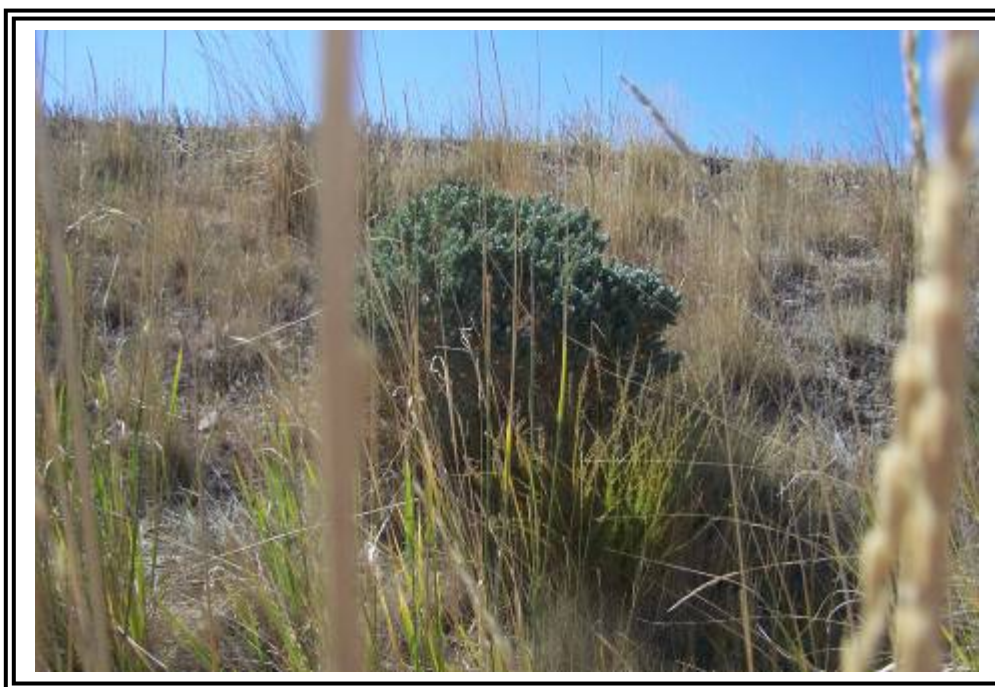
43

Sage shrub on east dike.

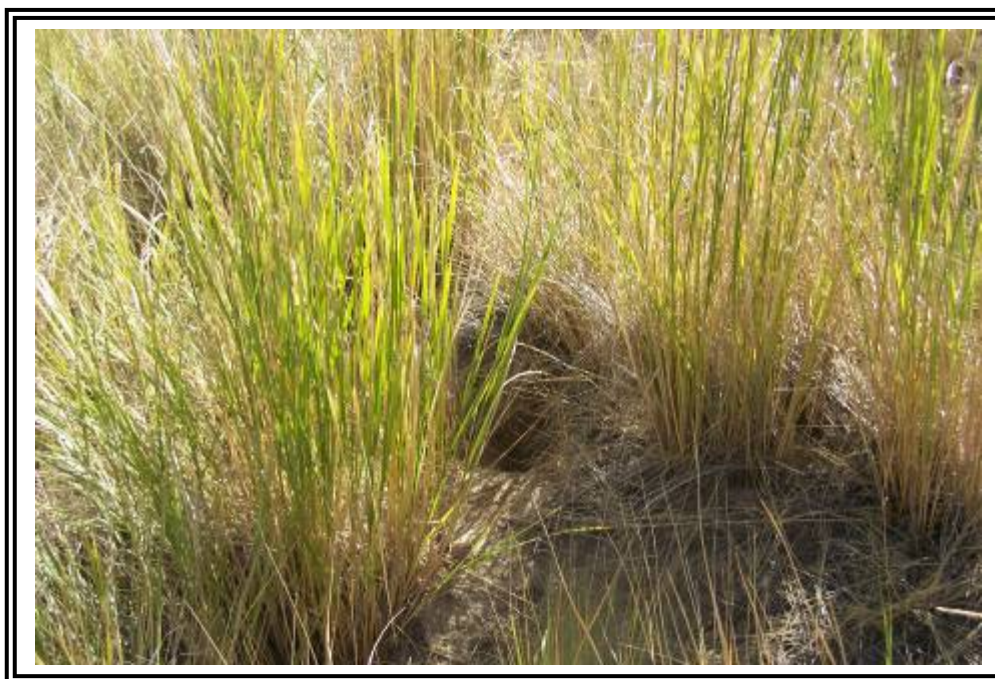
44

Animal burrow on east dike.

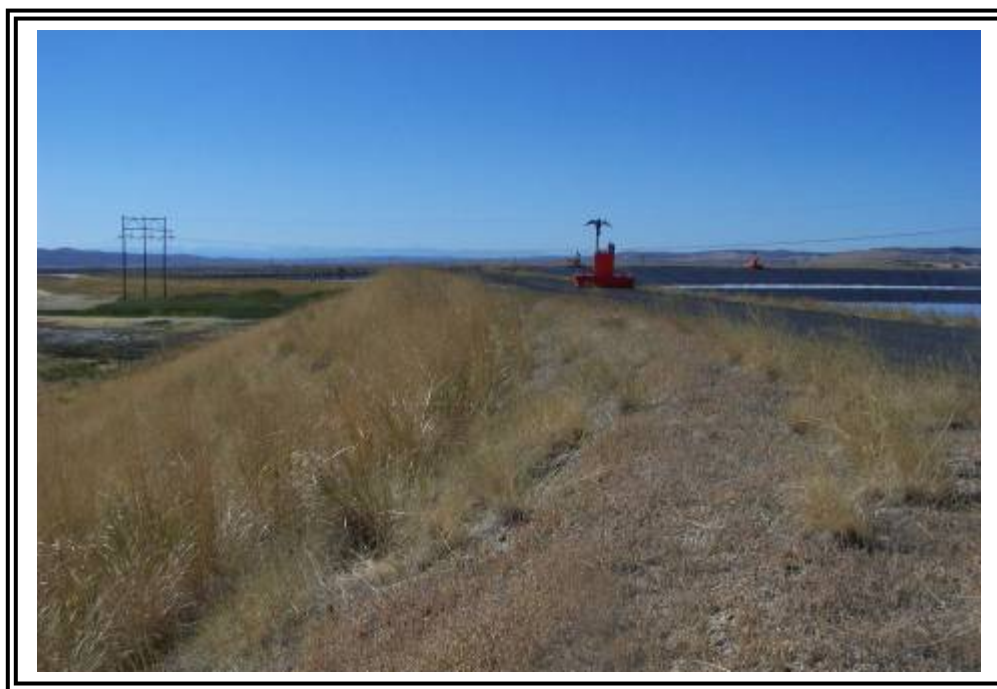
45

Downstream slope of east dike looking south.

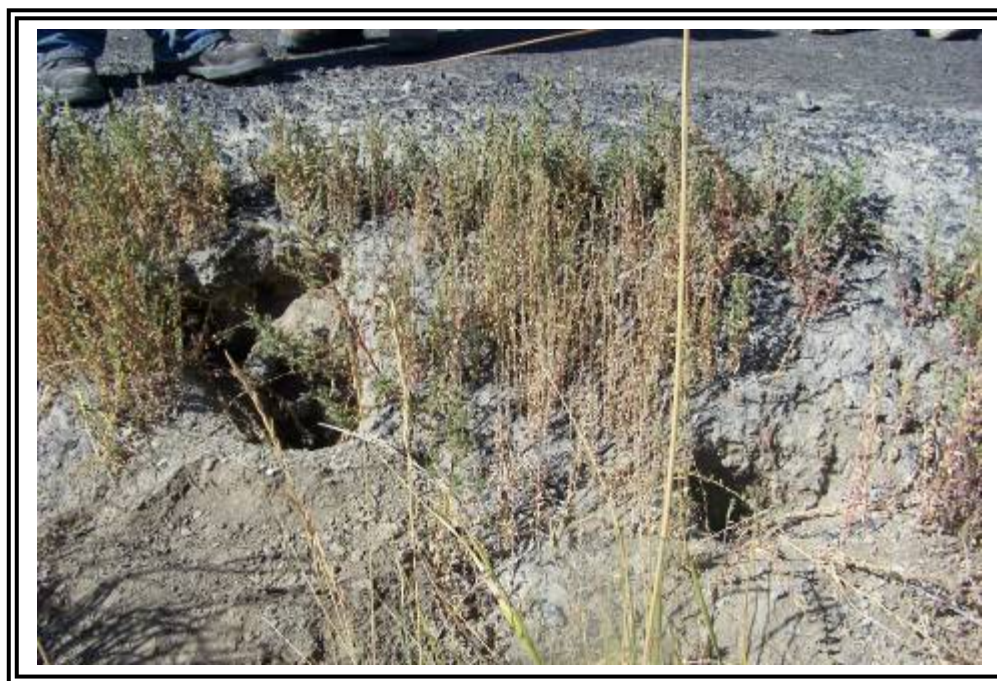
46

Animal burrows.

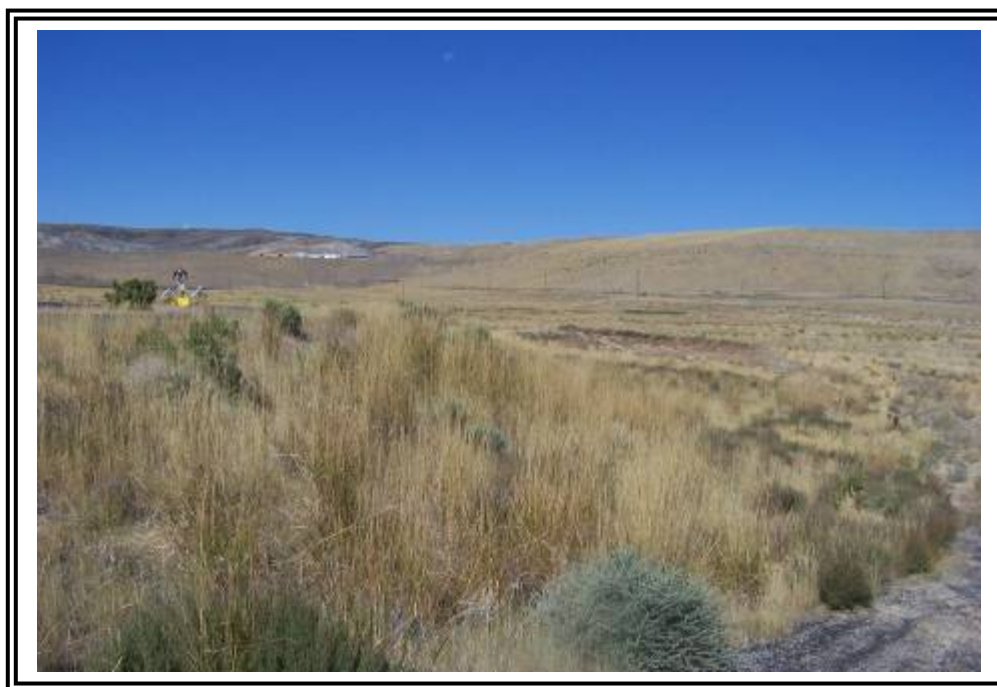
47

West end north dike looking west.

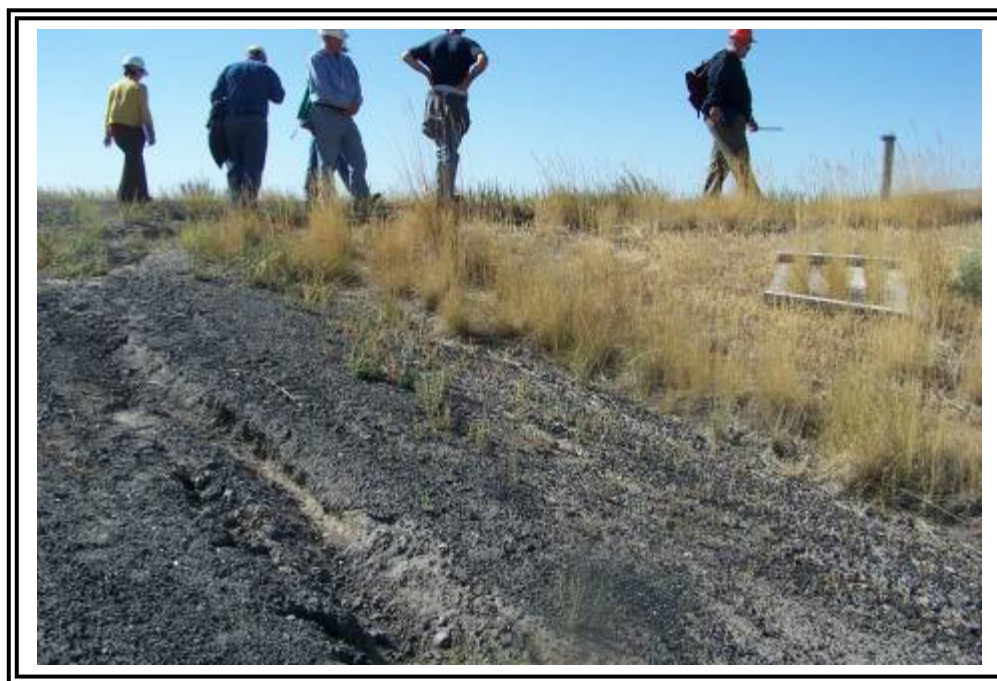
48

Erosion rivulet at access road ramp at west end of north dike.

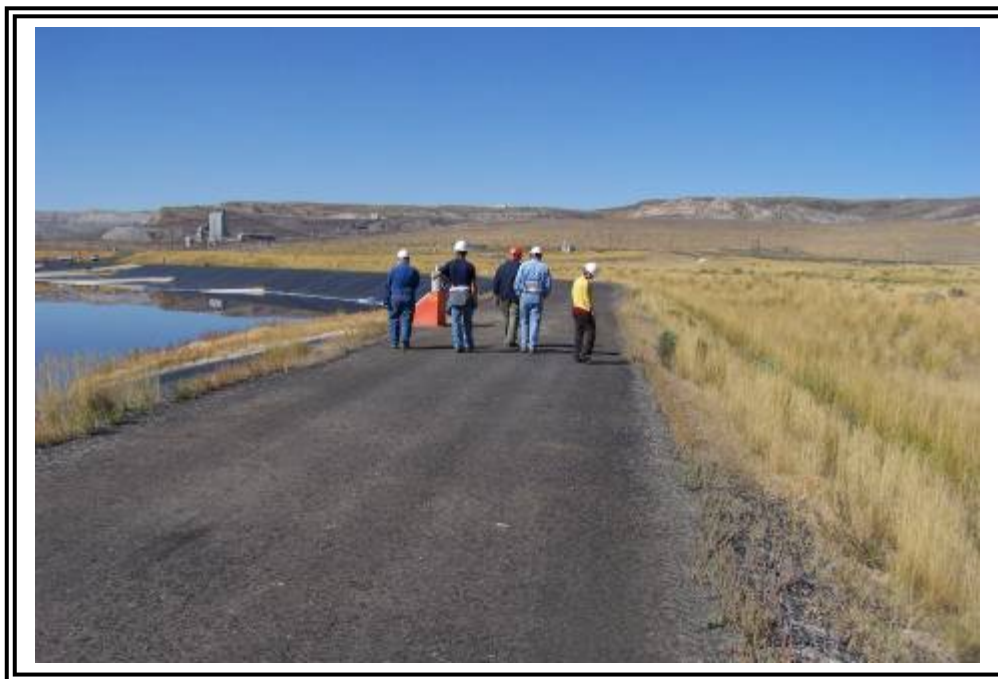
50

Crest of north dike looking northwest. Blends into natural ground.

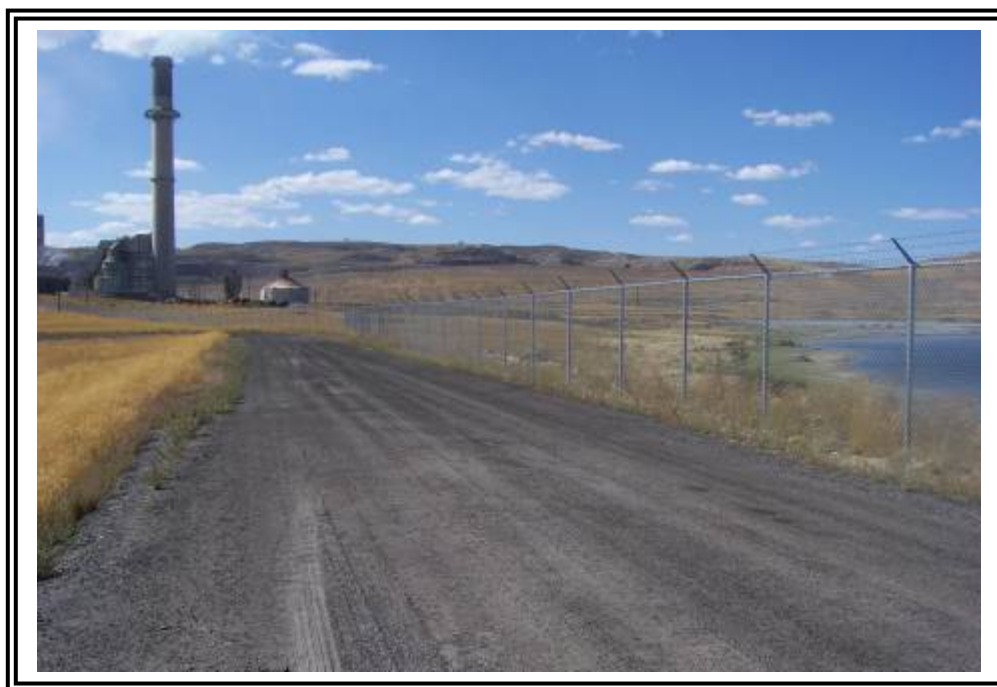
51

South abutment of Intermediate Dike looking west.

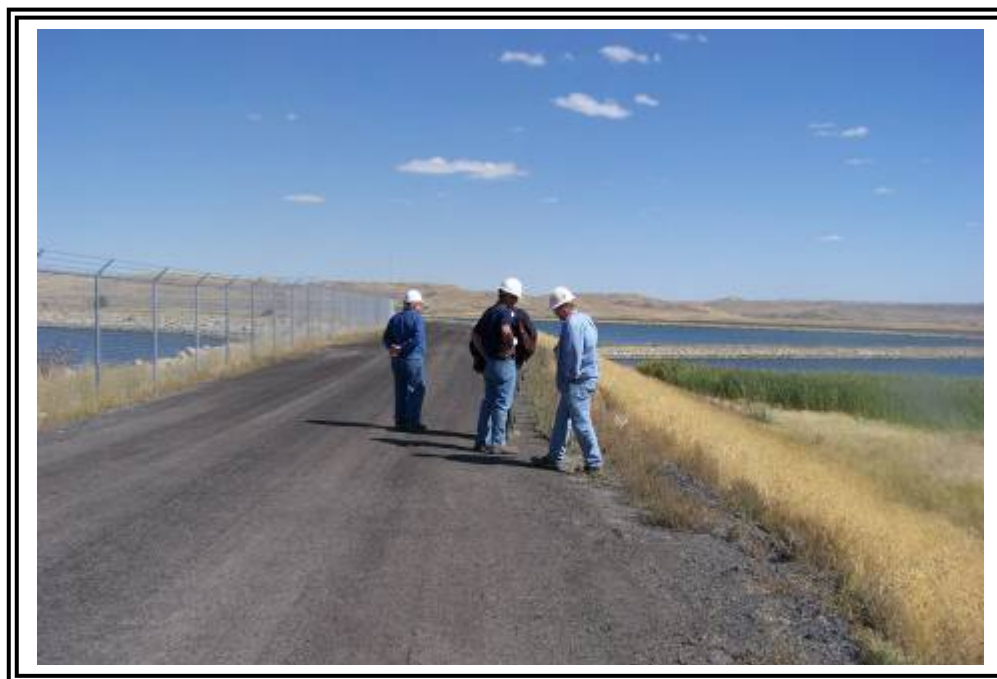
52

Crest of south end of Intermediate Dike looking east.

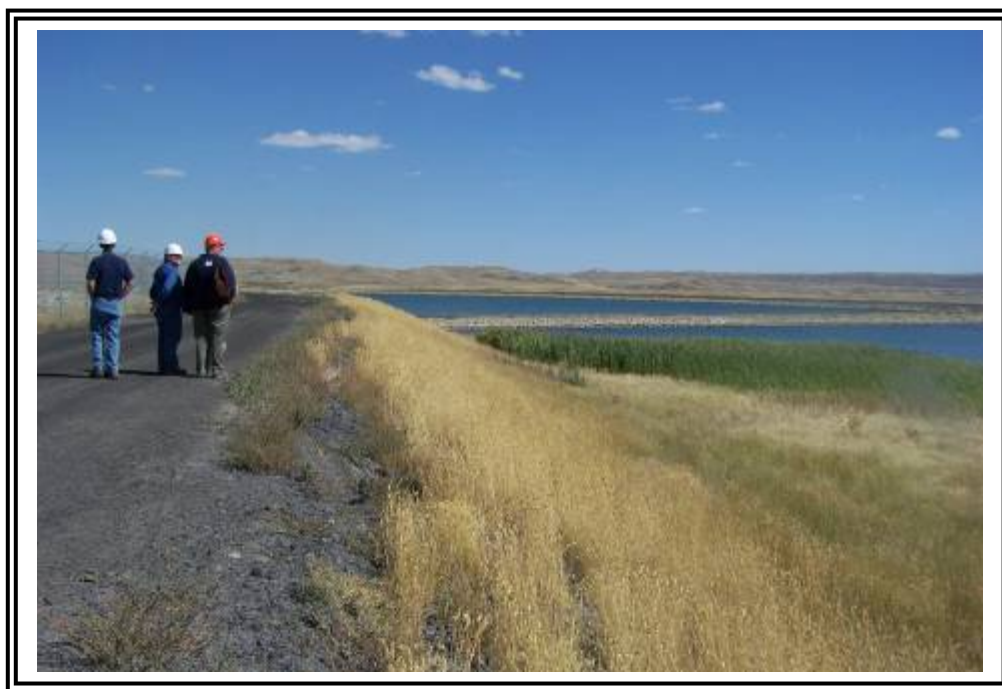
53

Downstream slope of Intermediate Dike looking east.

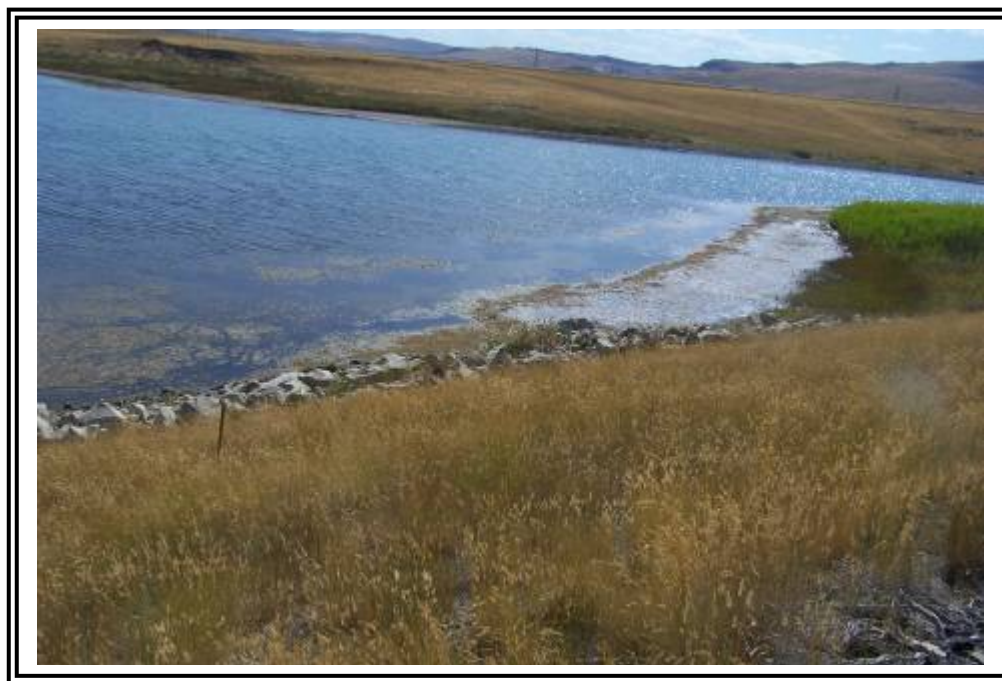
54

Clearwater Pond at toe of south portion of Intermediate Dike.

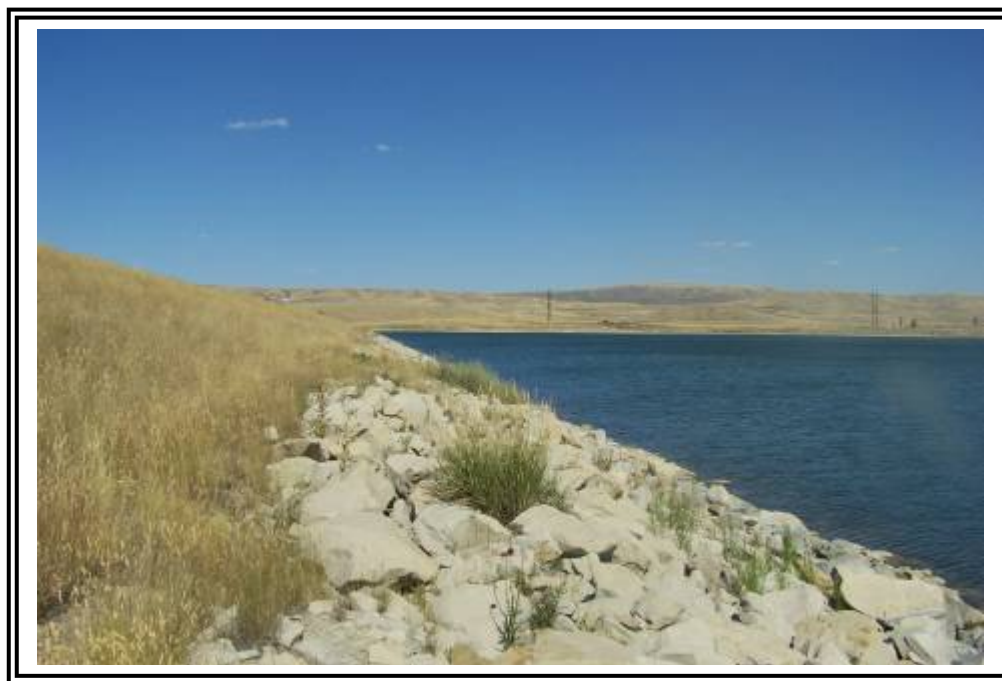
56

Downstream slope of Intermediate Dike looking northeast.

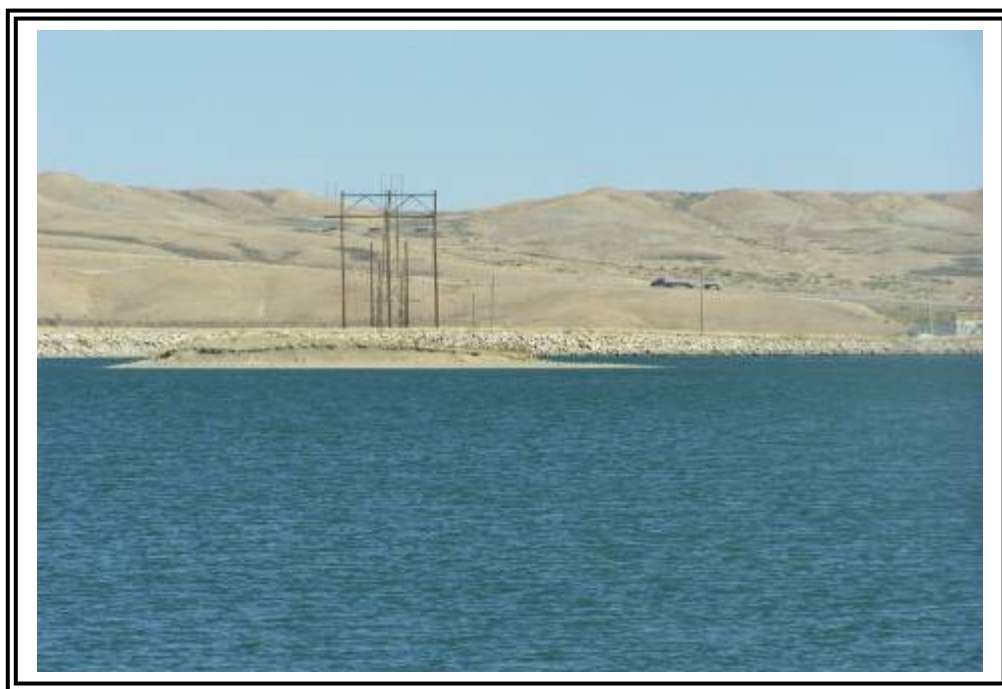
57

Island in Clearwater Pond maintained for bird nesting habitat.

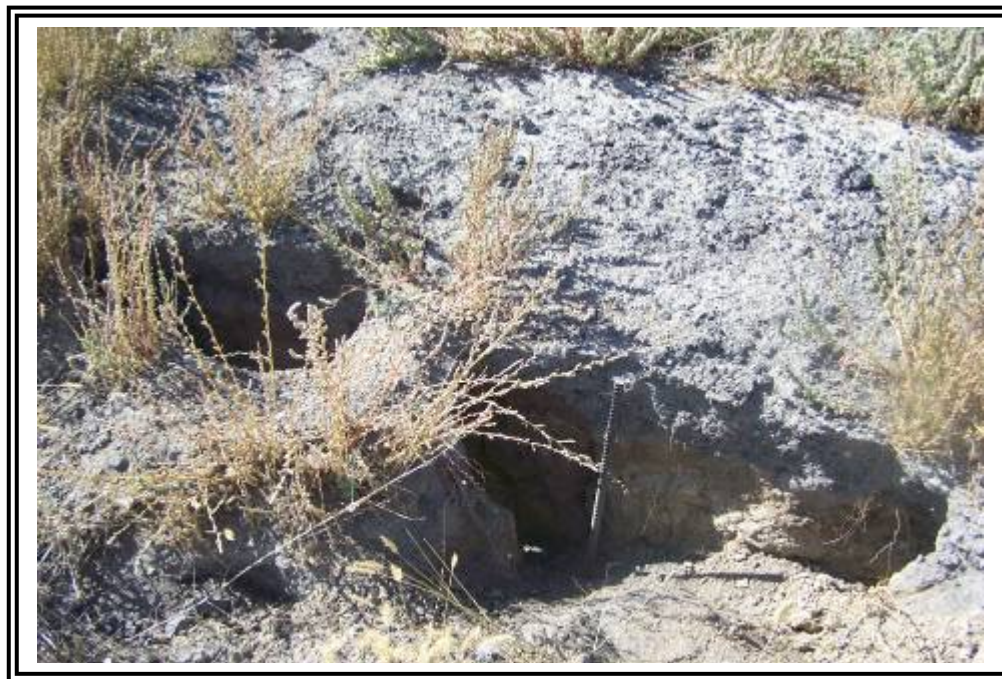
Animal burrows were observed in several locations on the downstream slope of the intermediate dike such as shown in Photos 58 and 68. Near the northeast corner of the Intermediate Dike, a crack was observed adjacent to an animal burrow as shown in Photo 65. The crack appeared to be related to the grading of the access road material.

Animal burrows on downstream slope of Intermediate Dike.

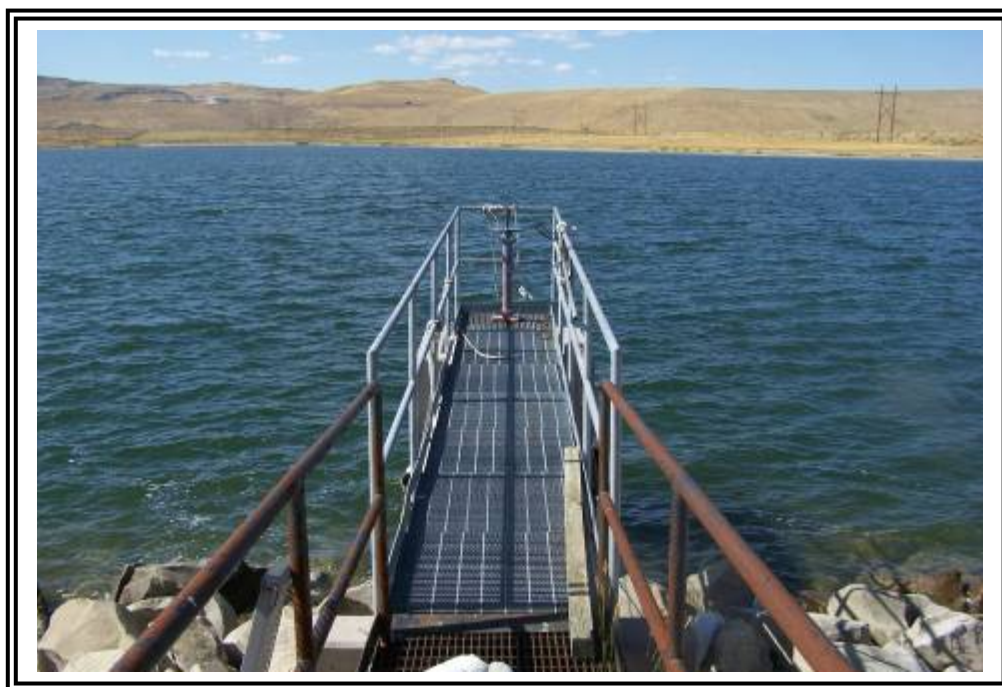
59

Decant structure in Primary Pond (looking northwest).

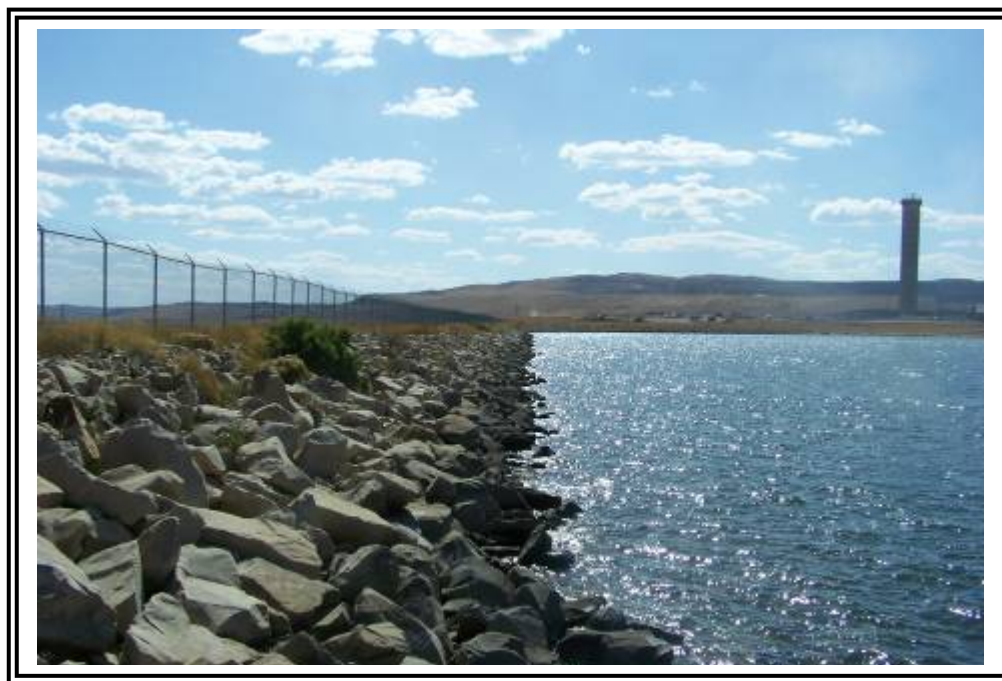
The upstream slope of the Intermediate Dike is covered in rip rap as shown in Photos 60 and 61. This slope is uniform and well maintained although occasional shrubs were observed growing through the rip rap. The downstream slope is vegetated with crested wheatgrass. Isolated sage bushes were observed as shown in Photo 64. Where the downstream slope is adjacent to the Clearwater Pond, rip rap protection armors the lower portion of the slope as shown in Photo 56. Away from the Clearwater pond the slope is fully vegetated as shown in Photo 66.

Upstream slope of Intermediate Dike looking southwest.

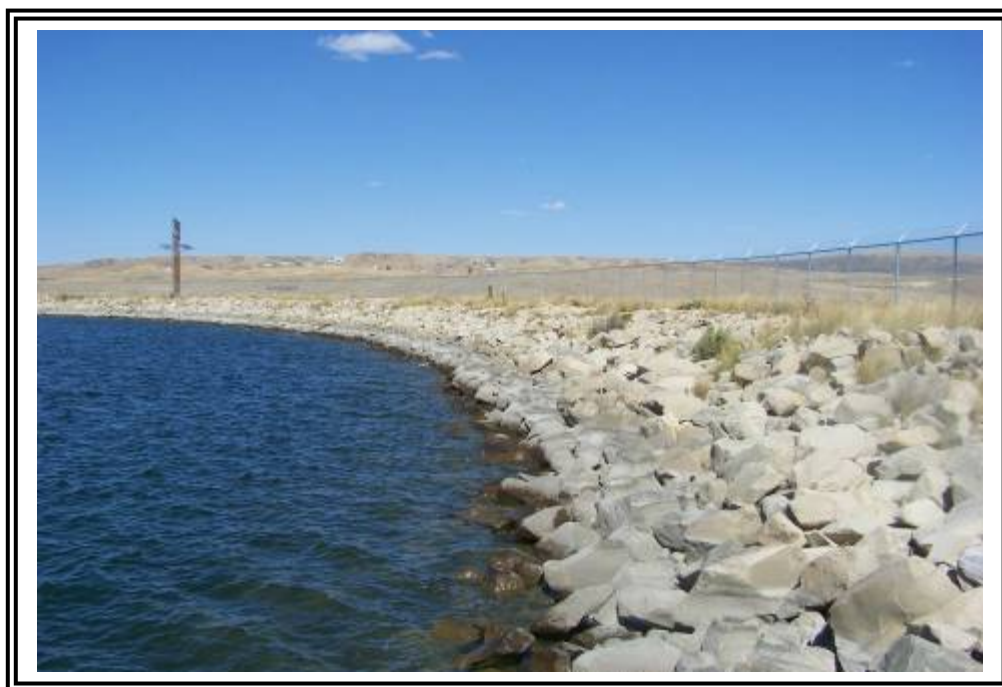
61

Upstream slope of Intermediate Dike looking northeast.

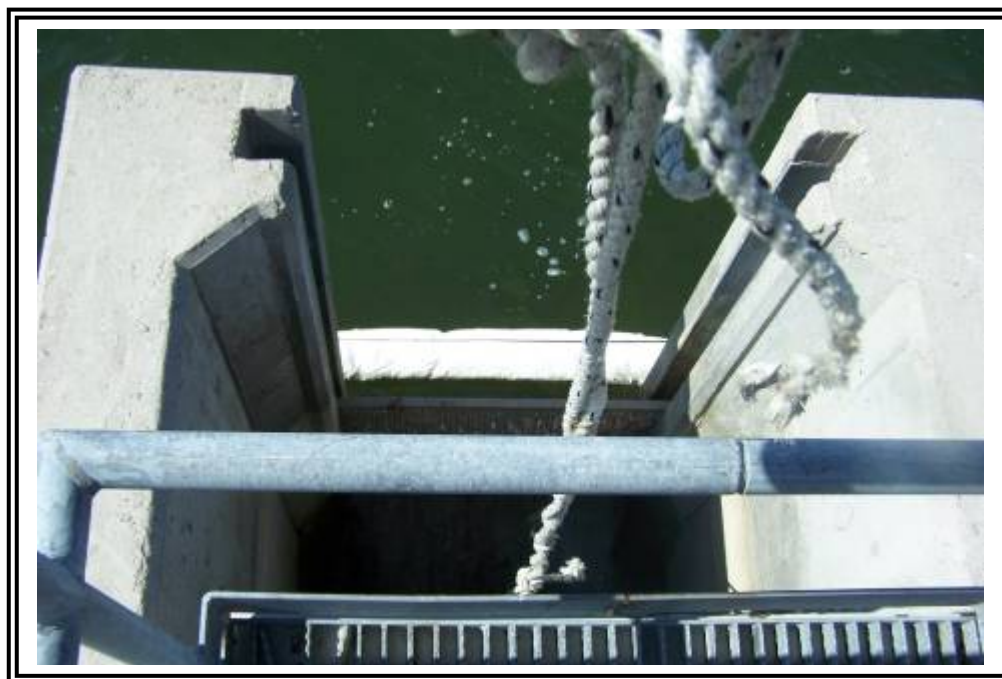
62

Decant structure in Primary Pond.

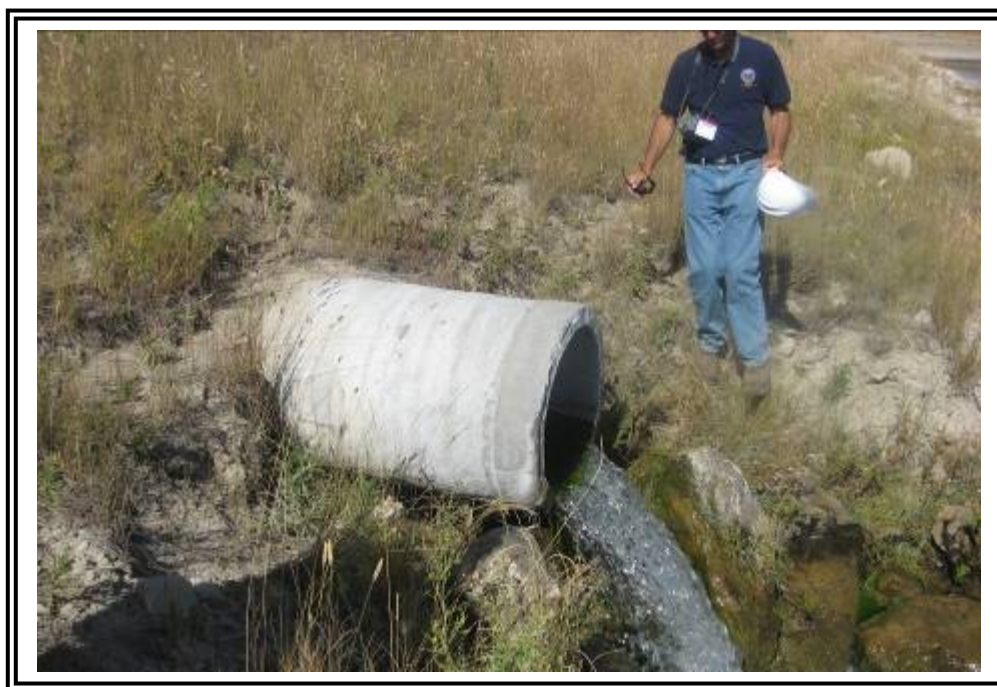
63

Discharge from Primary Pond into Clearwater Pond.

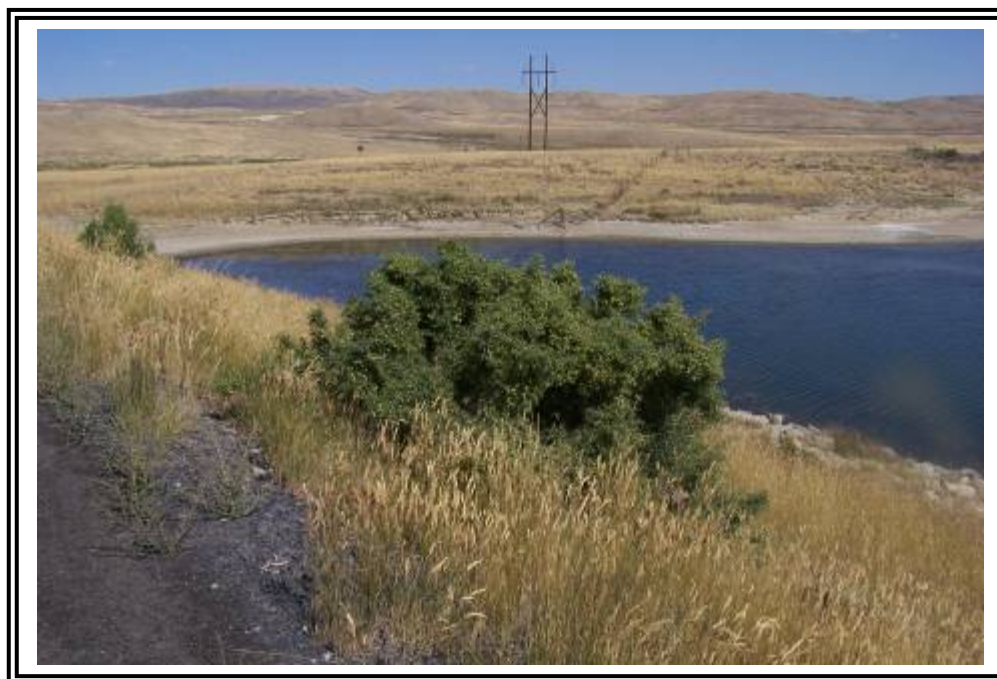
64

Sage brush on downstream slope of Intermediate Dike.

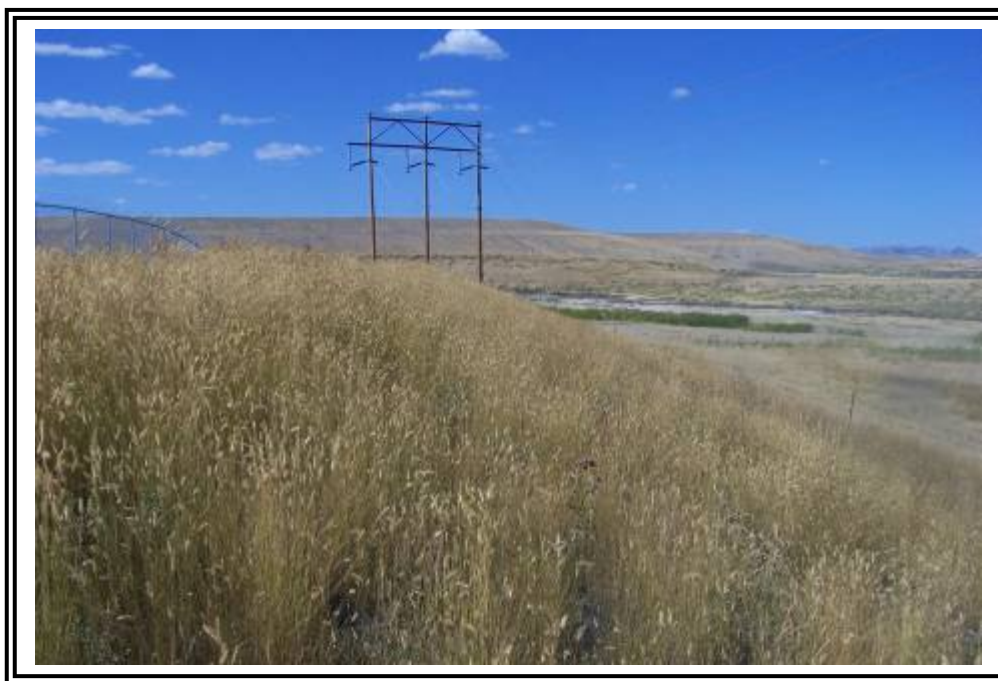
66

Downstream slope at northeast corner of Intermediate Dike looking north.

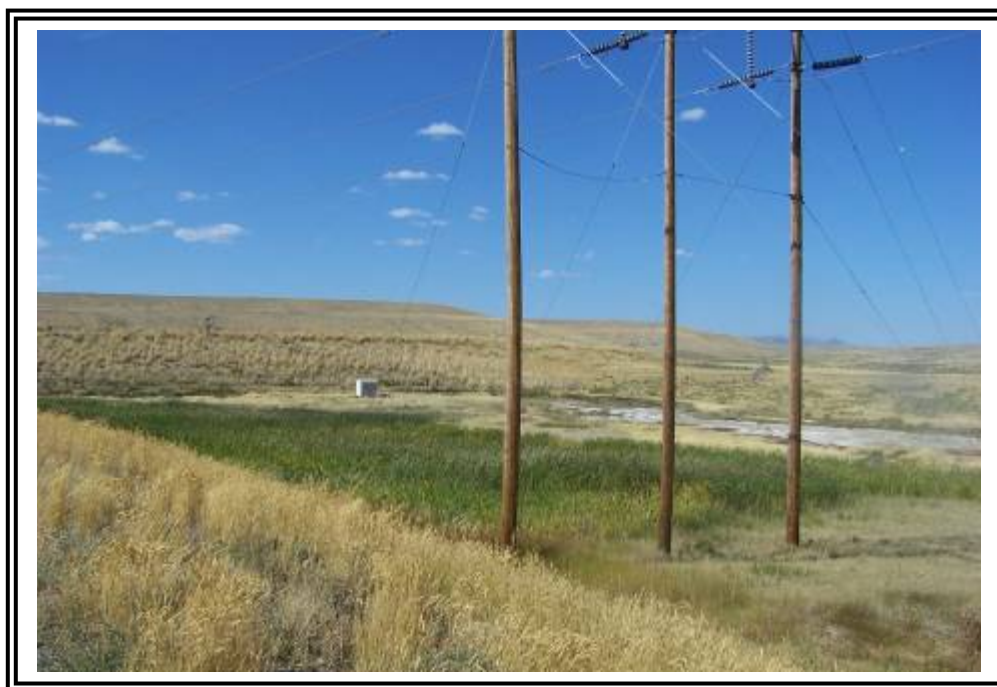
67

Possible seepage area at north end of Intermediate Dike. Adjacent but downstream of FGD #2 pump back area.

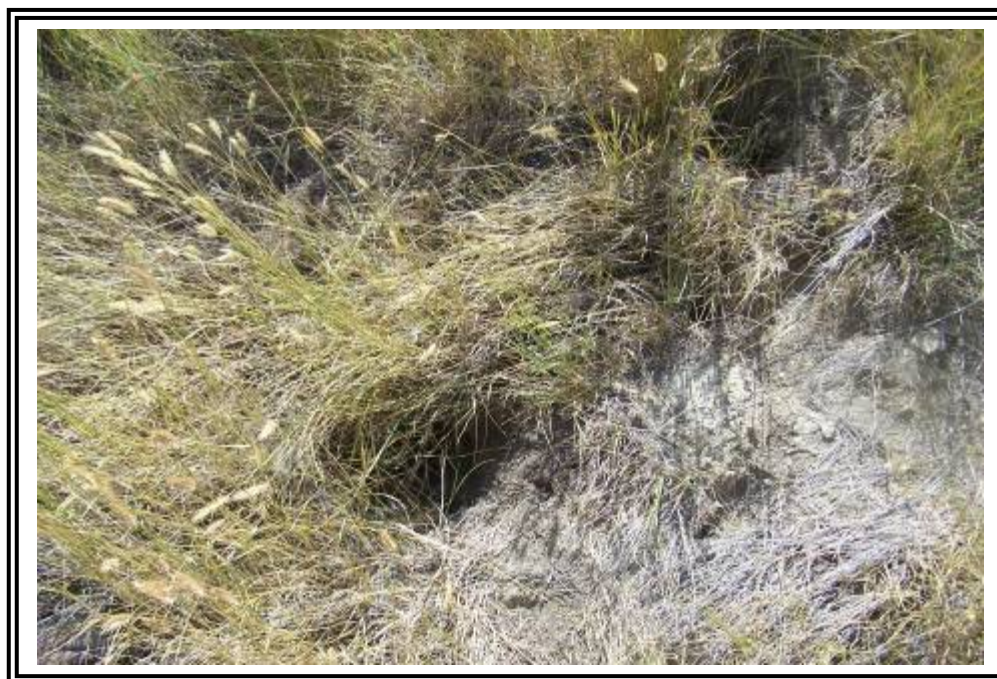
68

Animal burrow on north end of Intermediate Dike.

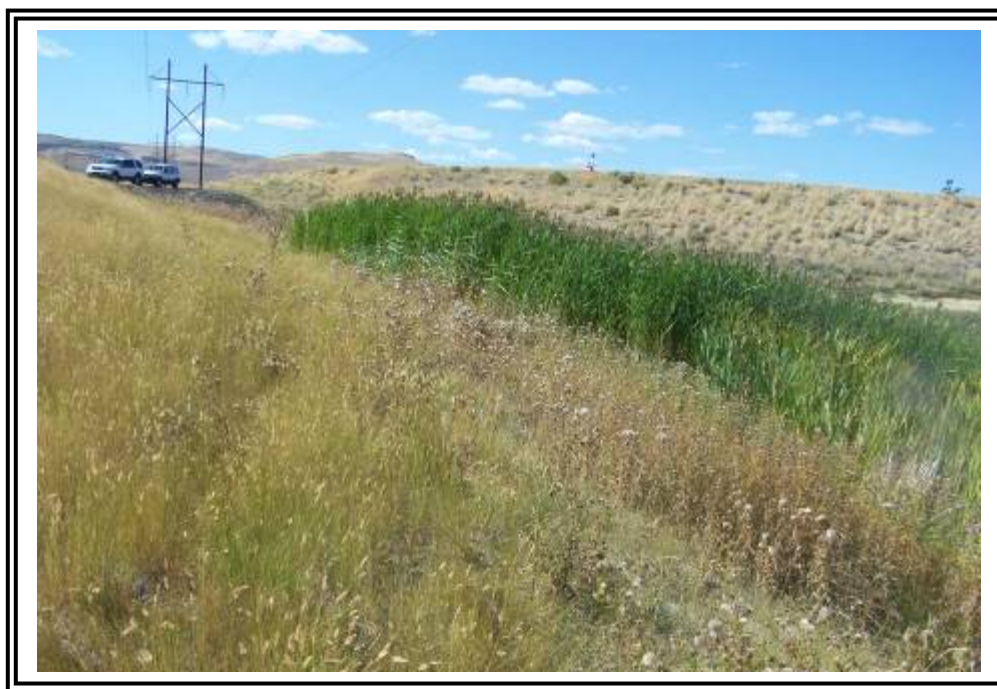
69

Looking toward North Abutment (where vehicles are parked).

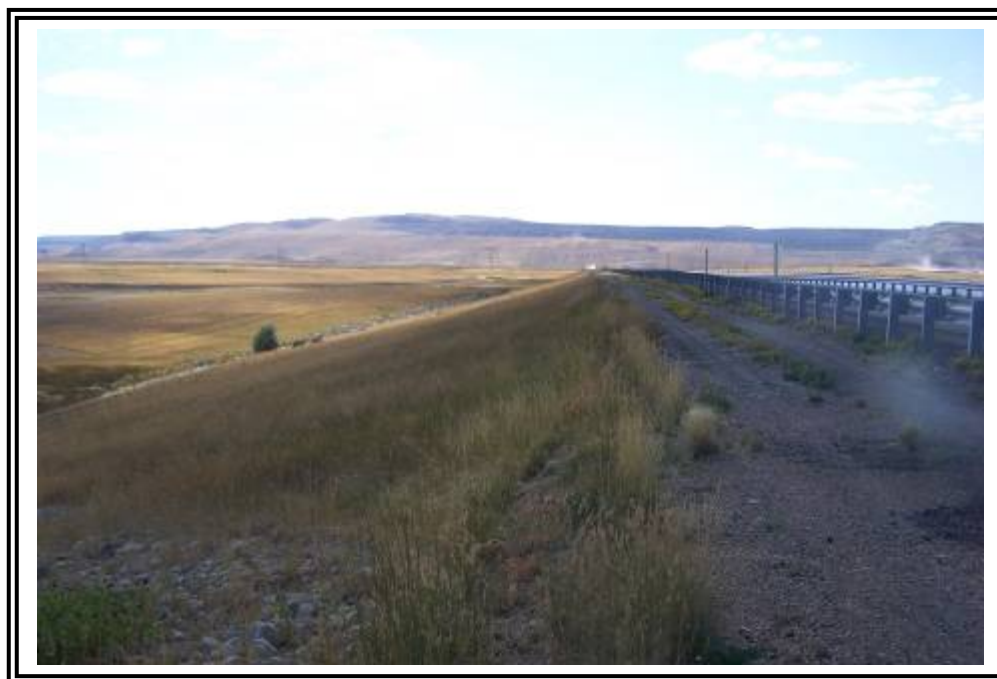
70

Crest/Downstream slope of the Main Dike looking west. Plant access road crosses the Main Dike.

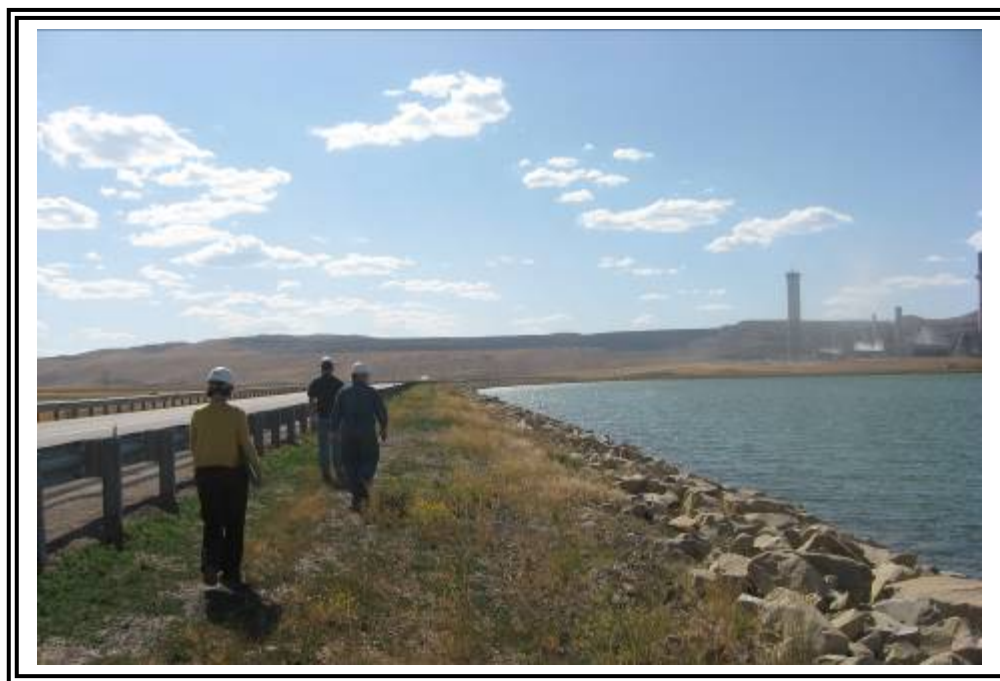
72

Upstream slope of Main Dike looking west.

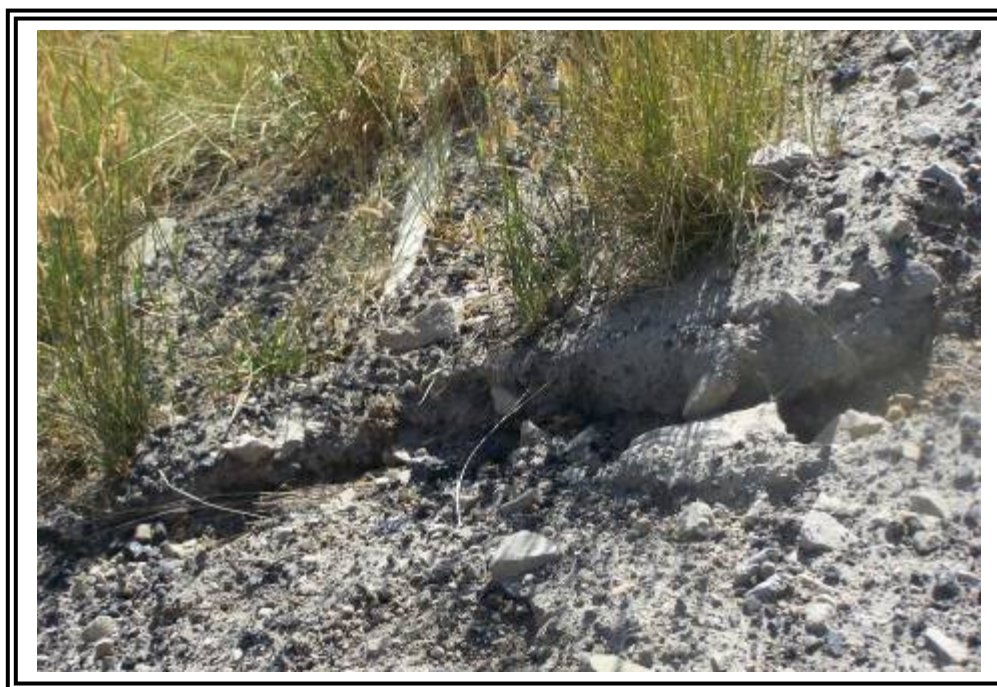
73

Occasional erosion rills, animal burrows, and sage bushes were observed on the downstream slope of the Main Dike. These types of features are shown in Photos 73, 79, and 82. The downstream toe contains a blanket drain that daylights at the toe based on details on drawings provided for review. This lower area of the embankment is protected with small rip rap.

Occasional erosion rills on downstream slope at crest of Main Dike.

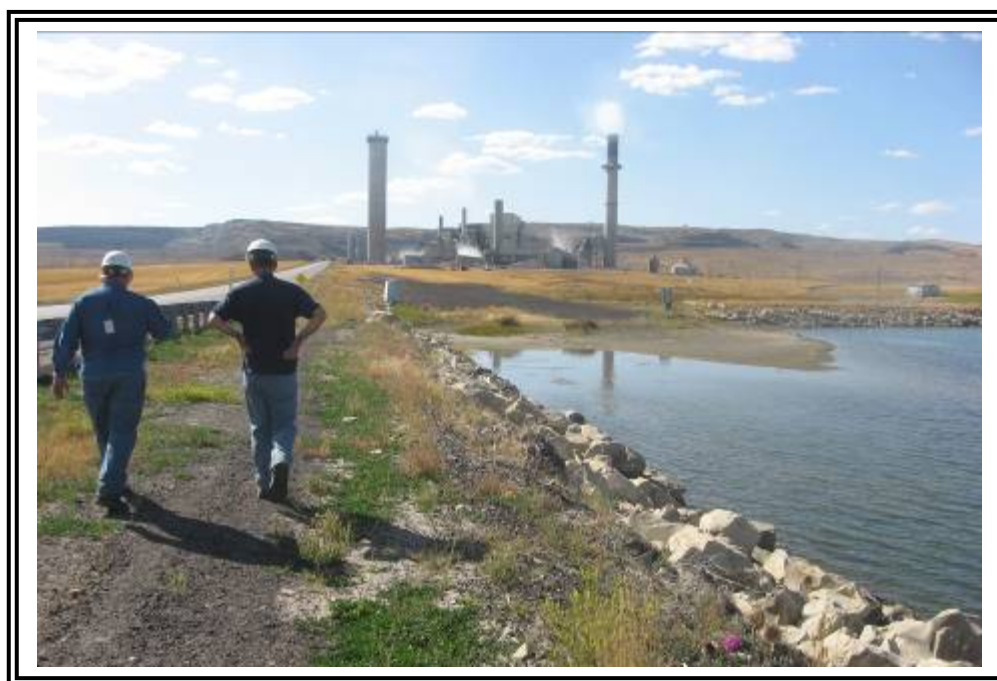
74

Upstream slope of Main Dike approaching west abutment looking west.

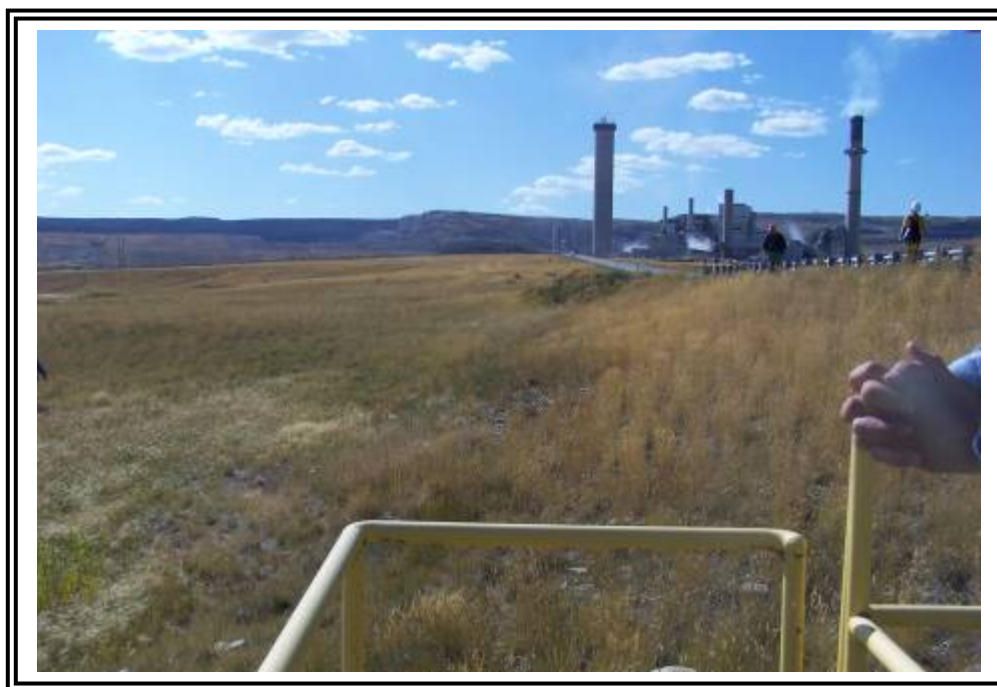
75

Downstream slope of Main Dike looking west from the outfall structure towards the west abutment.
